Cost Analysis of Selected Structures at Nike Site Summit

Battery Building at Site Summit

Directorate of Public Works Engineering Department
Fort Richardson

November 2008

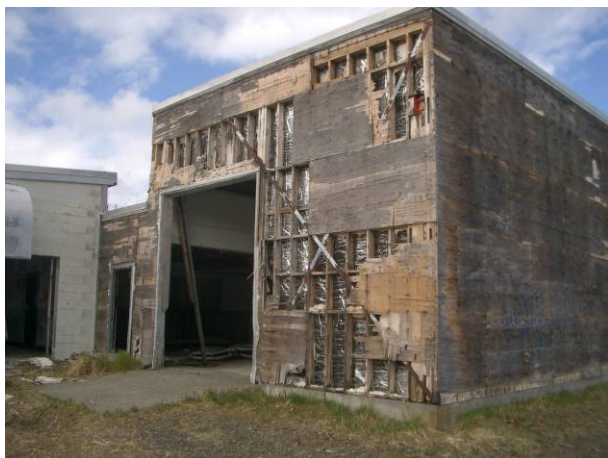
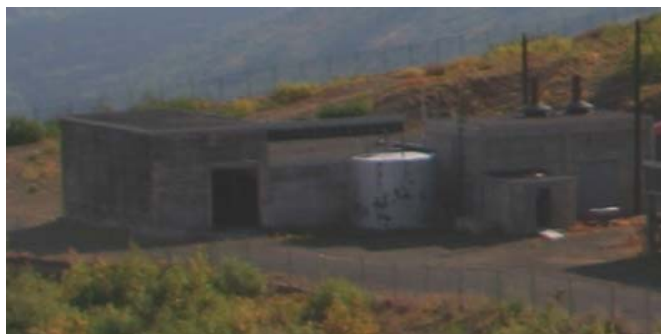
3.5 Launch Control Building 39225

Transit wallboard was potentially identified in rooms 103 and estimated to be 225 sq/ ft. Material was in good to fair condition and not viewed as an inhalation hazard in its current condition. Additionally, several heat expansion joints associated with the HVAC system were identified.

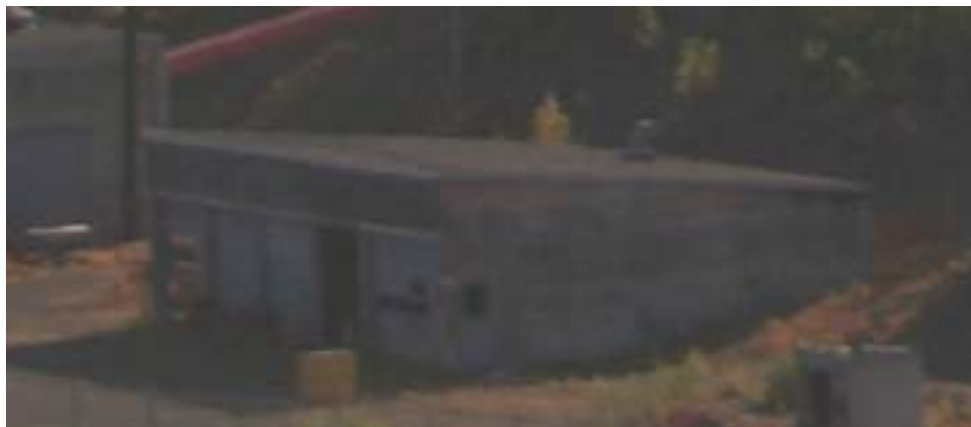
3.6 Vehicle Maintenance Shop 39227

Most of identified materials were noted in small quantities either scattered on the floor or intact in isolated locations. Lead-based paint removal was not estimated.

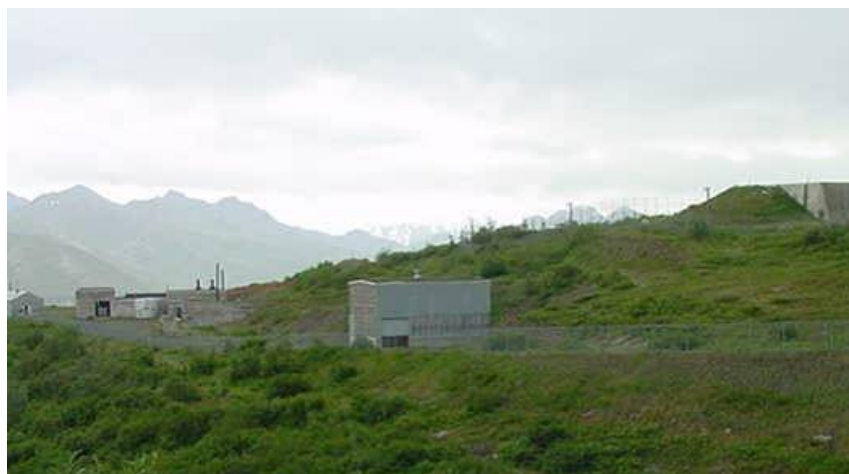
3.7 Guided Missile Maintenance Facility 39229

Again, most of identified materials were noted in small quantities either scattered on the floor or intact in isolated locations. Cost to remove all suspected ACM is \$25,000. Lead-based paint removal was not estimated.

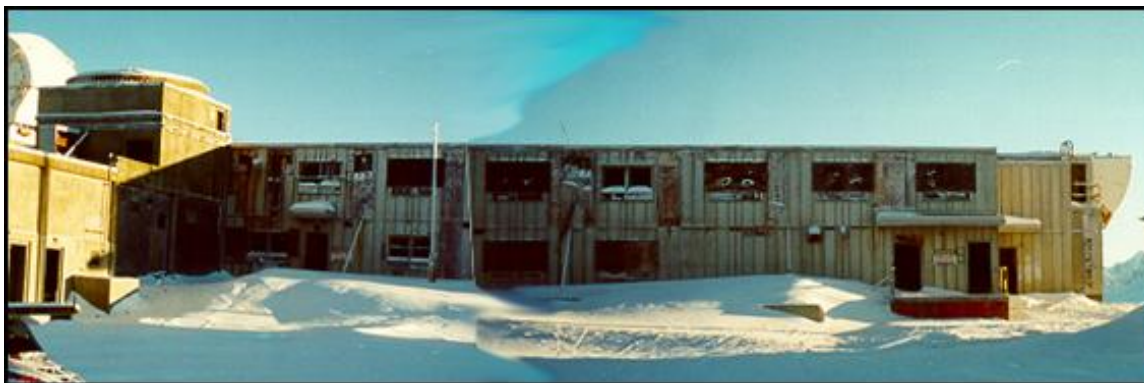
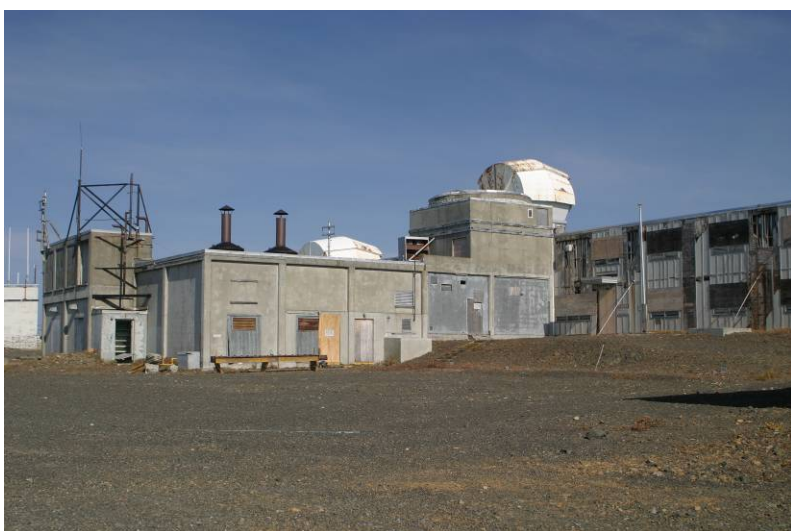
3.9 Battery Control and Barracks Building 39600

Exterior transite wallboard was observed to have been broken,

chipped and crushed. Material was observed scattered throughout the fenced upper site boundary area. Estimated quantity of wallboard is 9,900 sq/ft. This material will need to be removed if access to the general public is proposed to reduce potential inhalation/ingestion hazard. This material represents the greatest exterior inhalation hazard observed on the site. Cost to stabilize the transite material still attached to the building will vary depending on the level of access the public will have to the site and the level of potential risk the command is willing to accept..

Pipe insulation wrap (thermal) was located in the utility tunnel, exterior walls in rooms 110, 112, 116, 118, 119, 123, 124, and within the mechanical room. Estimated linear footage of ACM pipe wrap is 3,750. All material was in poor to extremely poor condition. Broken and exposed friable material could be observed in several locations throughout the building. This material is considered friable and the inhalation hazardous is considered high. If this material is allowed to dry, the potential exposure hazard would change for high to extremely high. This material represents the single greatest identified suspected ACM inhalation hazard at the Nike Summit site.

Suspected ACM 9" x 9" asphalt tiles, leveling compound, and tile mastic were identified in rooms 111, 112, 113, 115, 116, 117, 118, 119, 120, 122, 123, 124, 126, and 127. Estimated quantity of ACM tile is 10,250 sq/ft. General condition of material was fair to poor with most tiles broken into numerous small pieces. In most locations, tiles mastic and leveling compound were either exposed on the bare flooring/tiles or broken into small pieces and scattered around the floor. The potential hazard associated with this material is considered medium to low given the wet conditions and potential friability.. Removal of all floor tiles and mastics may not be possible without causing damage to the flooring.

Wainscot cement asbestos board were identified in all rooms throughout the building and average four in height with the exception of rooms 106, 108, 134 and 135 where they ranged from six to seven feet in height. Most material was in fair condition with a potential medium to low inhalation hazard given the wet condition and potential friability. Estimated volume of CAB is 24,000 square feet. It is unclear given the current condition of the building if removal could be completed in all areas of the building without causing damage to the building.

Acoustical ceiling tiles and mastic were observed in rooms 110, 111, 112 and 124. The condition of this material varied depending on whether it was still attached to the ceiling or whether it was lying on the floor. The tiles and mastic attached to the ceiling are considered a low friable and inhalation hazard while those tiles and mastic lying in the floor are in extremely poor condition and considered a high hazard. Estimated quantity of acoustical tiles is 3,600 sq/ft. Removal and disposal of all ceiling tiles on lying on the floor is estimated at \$ 12,000.

A total of eight fire doors were identify and assumed to contain ACM in this building. No damage was noted on the doors and no asbestos suspected material was exposed. Overall condition of the doors appears to be good to fair. It is believed that the fire doors could remain in the building in their current condition without adding to the existing inhalation risk associated with asbestos. All other identified materials were observed in limited quantities.

¹Cost of demolition for the Battery Building calculated to include demolition of the superstructure, abatement of hazardous materials and retention of the concrete foundation.

²Cost of stabilization for the Battery Building calculated to include stabilization of the concrete portion of the building only, replacement of the roof and siding, abatement of hazardous materials, and sealing off of entrances.

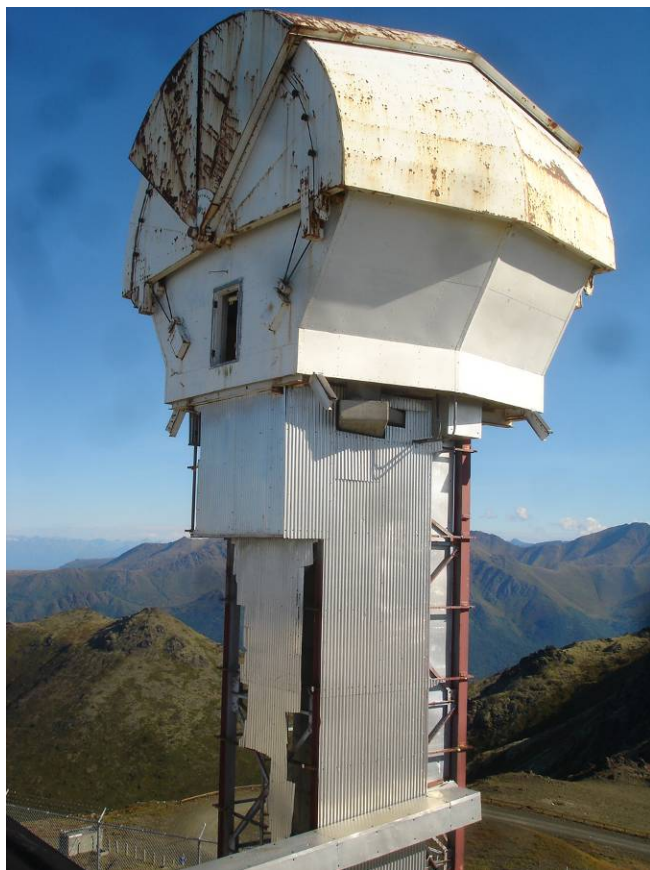
3.10 Target Ranging Radar

Estimated linear footage of ACM pipe wrap is 300 lineal feet. All material was in poor to extremely poor condition. Broken and exposed friable material could be observed in several locations throughout the building. This material is considered friable and the inhalation hazard is considered high. If this material is allowed to

dry, the potential exposure hazard would change for high to extremely high.

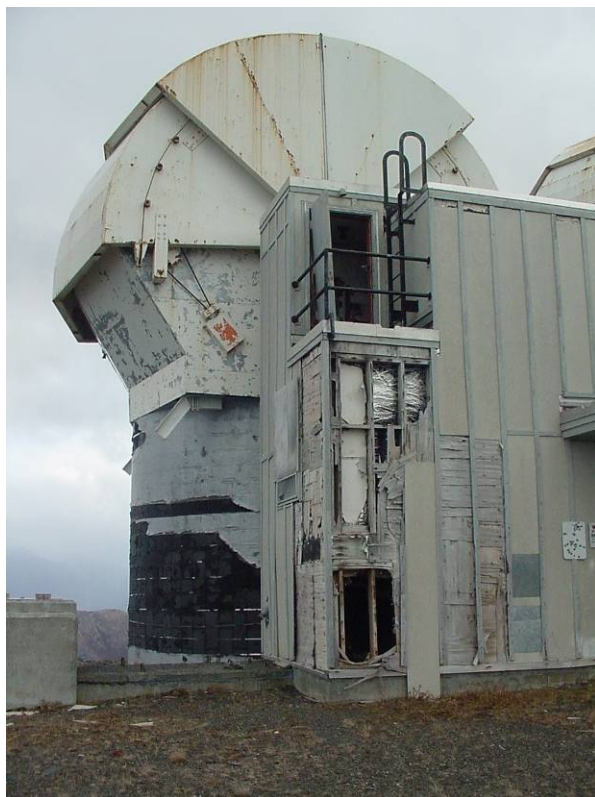
3.11 Target Tracking Radar

Estimated linear footage of ACM pipe wrap is 300 liner feet. All material was in poor to extremely poor condition. Broken and exposed friable material could be observed in several locations throughout the building. This material is considered friable and the inhalation hazard is considered high. If this material is allowed to dry, the potential exposure hazard

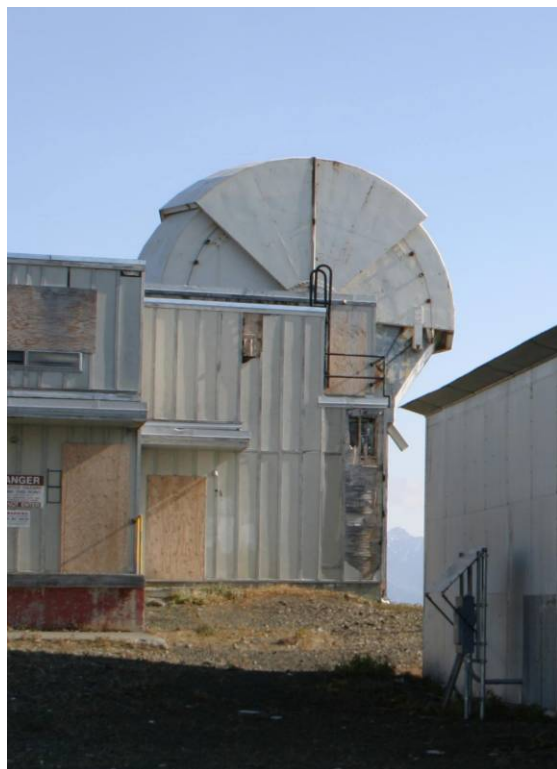
3.12 Missile Tracking Radar

Estimated linear footage of ACM pipe wrap is 300 linear feet. All material was in poor to extremely poor condition. Broken and exposed friable material could be observed in several locations throughout the building.

hazard is considered high. If this material is allowed to dry, the potential exposure hazard would change from high to extremely high.

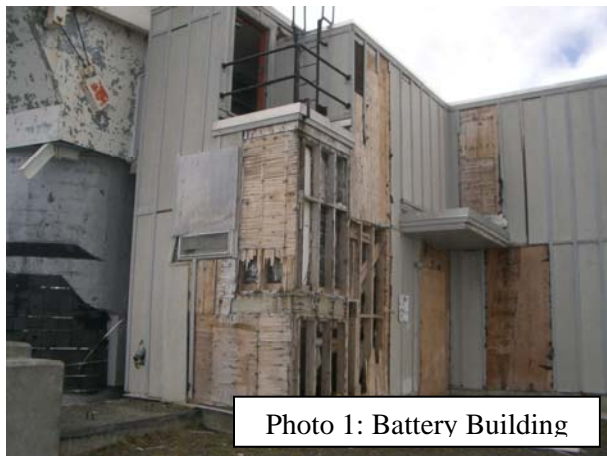
Photo 1: Battery Building

All existing sheet metal bears the scars of wind borne projectiles. Whole areas of plywood sheathing have been blasted away from the Battery Building (See photo #1). The windward sides of the water tanks supporting the radar clamshells have been weather beaten to the extent that the majority of the insulation has been scoured away. That is no small matter when you consider that the insulation utilized was a foamglass product (See photo #2).

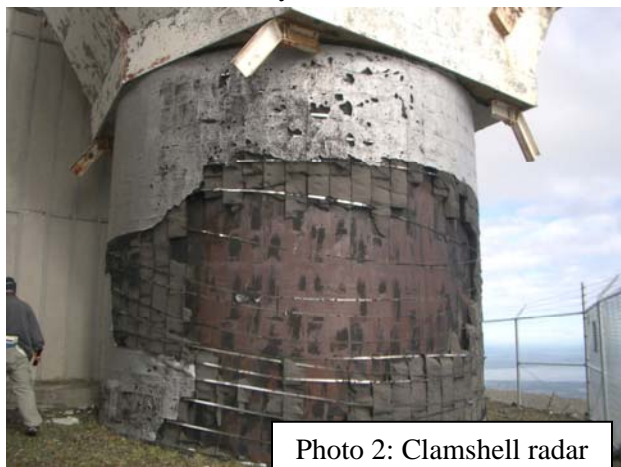
Photo 2: Clamshell radar

Foamglass insulation is a cellular glass insulation manufactured by Pittsburgh Corning <http://www.foamglasinsulation.com/> for heavy duty industrial installations. It is promoted as having long term performance, being dimensionally stable and of high compressive strength. It can be utilized where it is subjected to heavy compressive loads for industrial loading such as under slabs bearing lift trucks etc. Yet the force of the wind at Site Summit has virtually eliminated the material on the wind exposed faces (it is more or less intact on the protected side) of the tanks. In photo #2 you can see striations resulting from wind erosion.

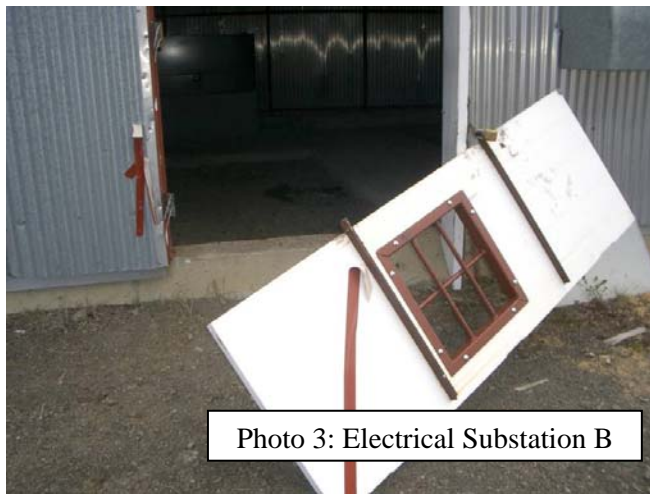
Photo 3: Electrical Substation B

Two weeks later on July 3rd, 2008 the Site Summit project estimating team was on site doing additional assessment. The team discovered substation "B" had been forcibly entered. A person or persons had used equipment of adequate mass to pull three inch fasteners from their restraints and pulled the adjacent steel structure from its attachment. See attached photos #3 and #4).
